Rock Island Arsenal Laboratory

LAMINAR CHROMIUM ELECTRODEPOSITS

Report No. 61-3826

Date 19 October 1961

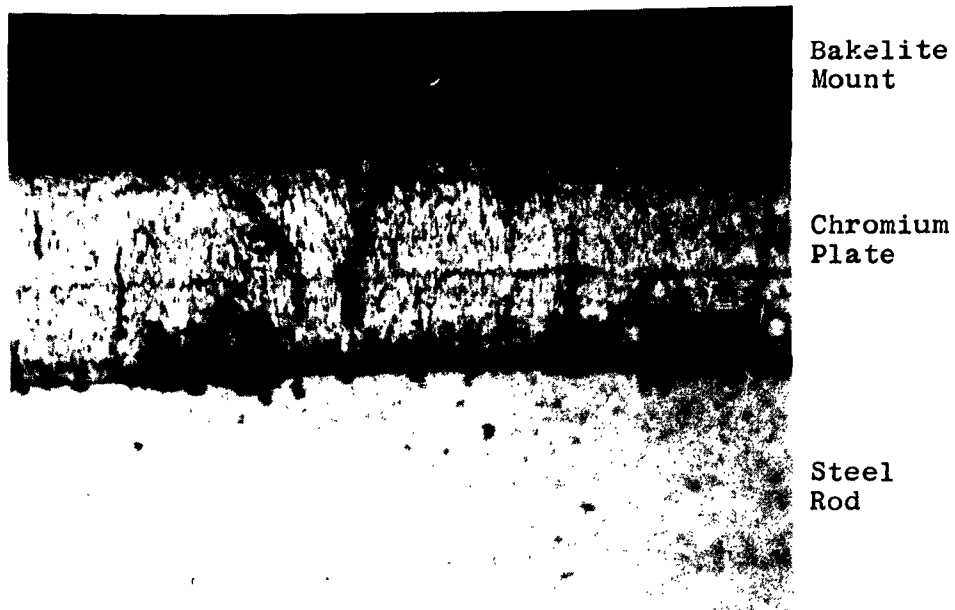
FIGURE 7 Laminated By Plating Solution Neg. #3083
Temperature Changes

CROSS SECTIONS OF LAMINAR CHROMIUM PLATED STEEL RODS
.0011 in. Plate 1000X

The time necessary to heat the plating solution to 138°F. and allow the solution to cool to 124°F. was too long a time cycle to have enough laminae in a one mil (.001 in.) thick coating. Figure 7 illustrates such a plate. There are only three laminae in the plate. It has been observed that in most instances at least three laminae are needed in order to stop a flaw or void in the plate. Close study of photomicrographs in this report bears out this statement.
